Analysis of the causes of breaks of Cu wires during the industrial wire drawing process

Beata Smyrak, Bartosz Jurkiewicz, Marek Gnielczyk

AGH University of Science and Technology,
Faculty of Non - Ferrous Metals,
Department of Metal Working and Physical Metallurgy of Non - Ferrous Metals

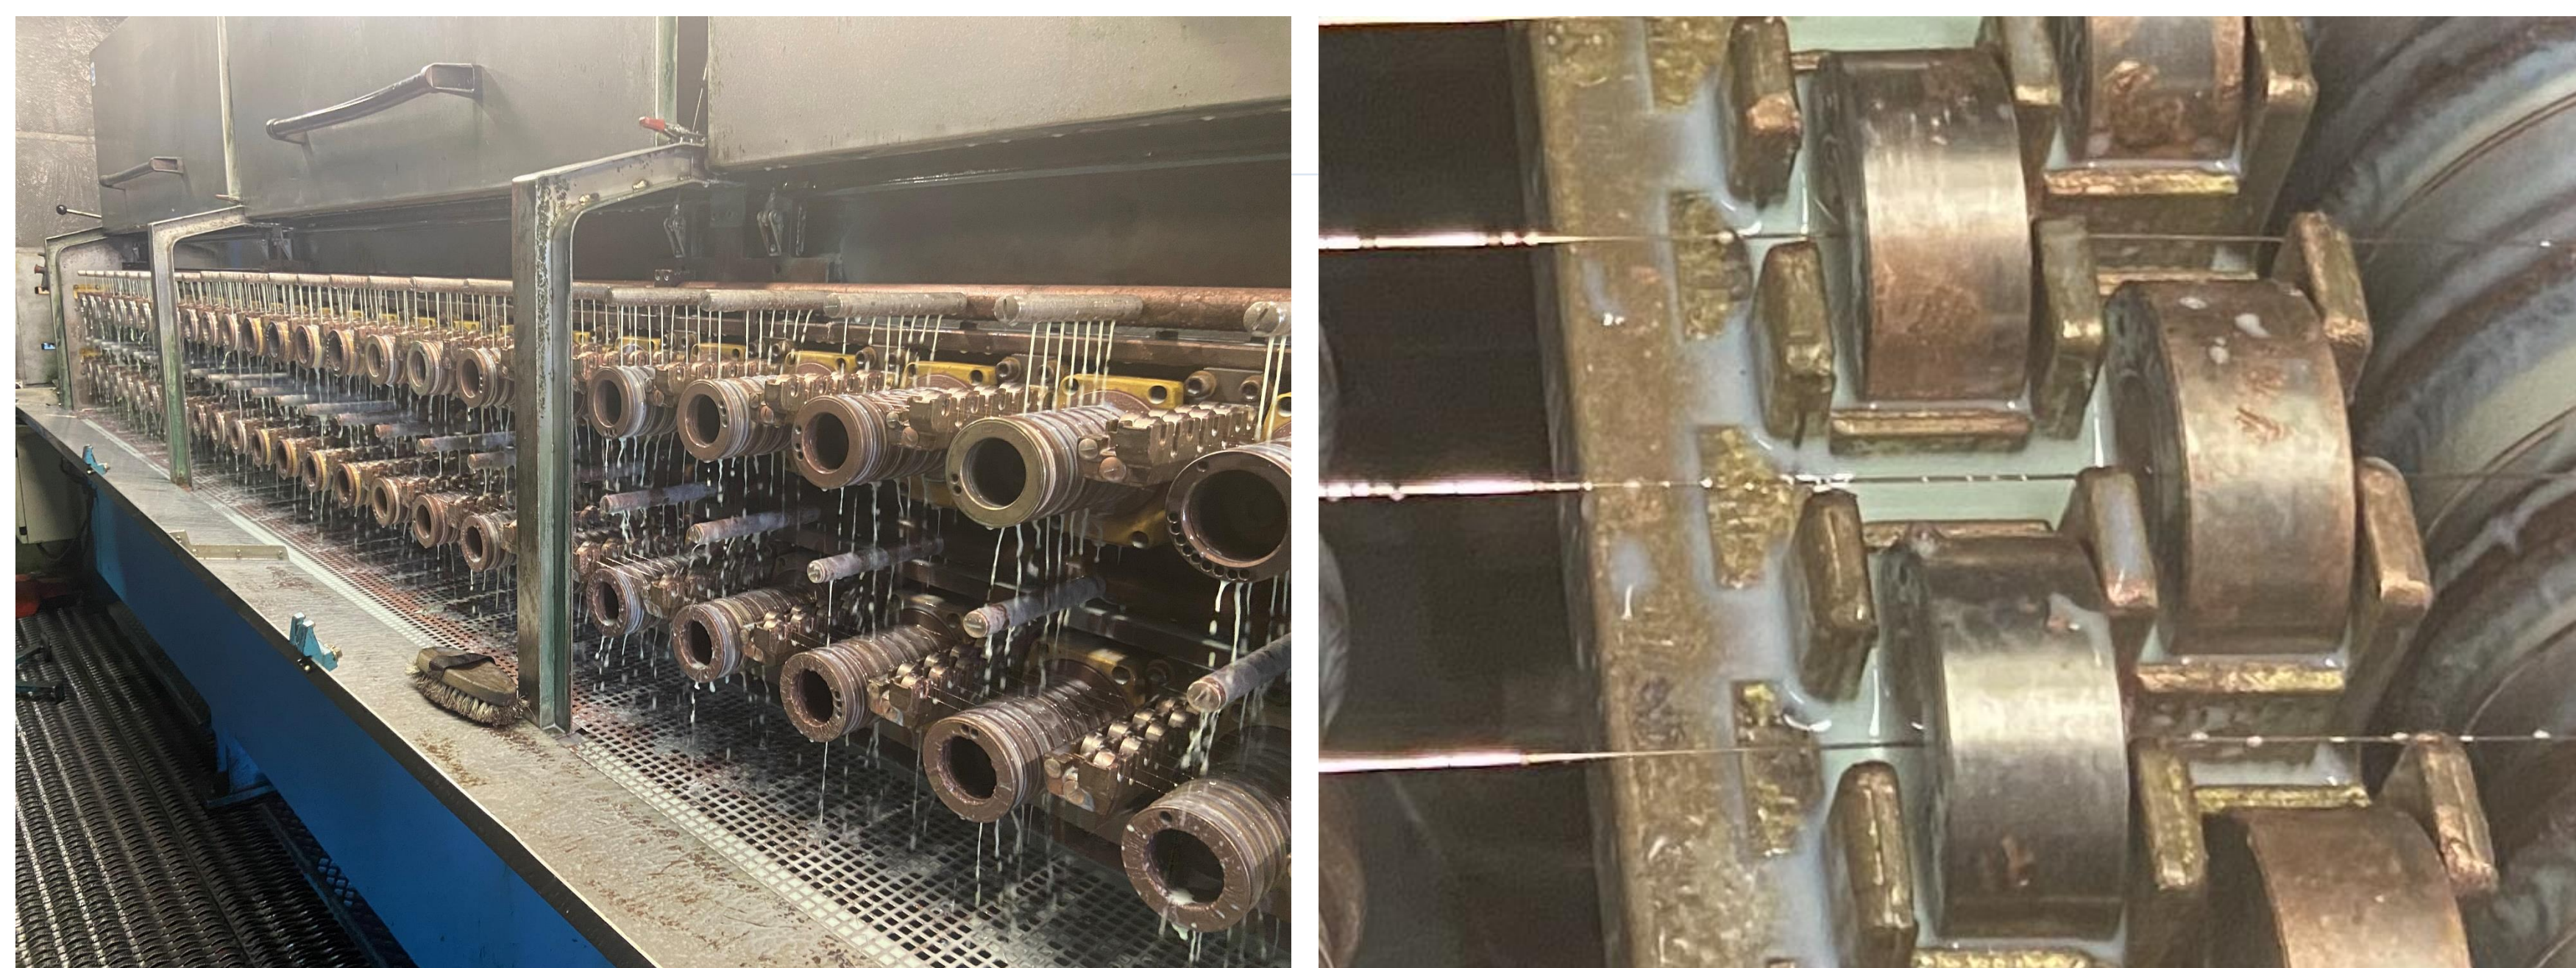
Fig.1. SEM image of Cu-ETP wires fracture and EBSD analysis, mag. x 500

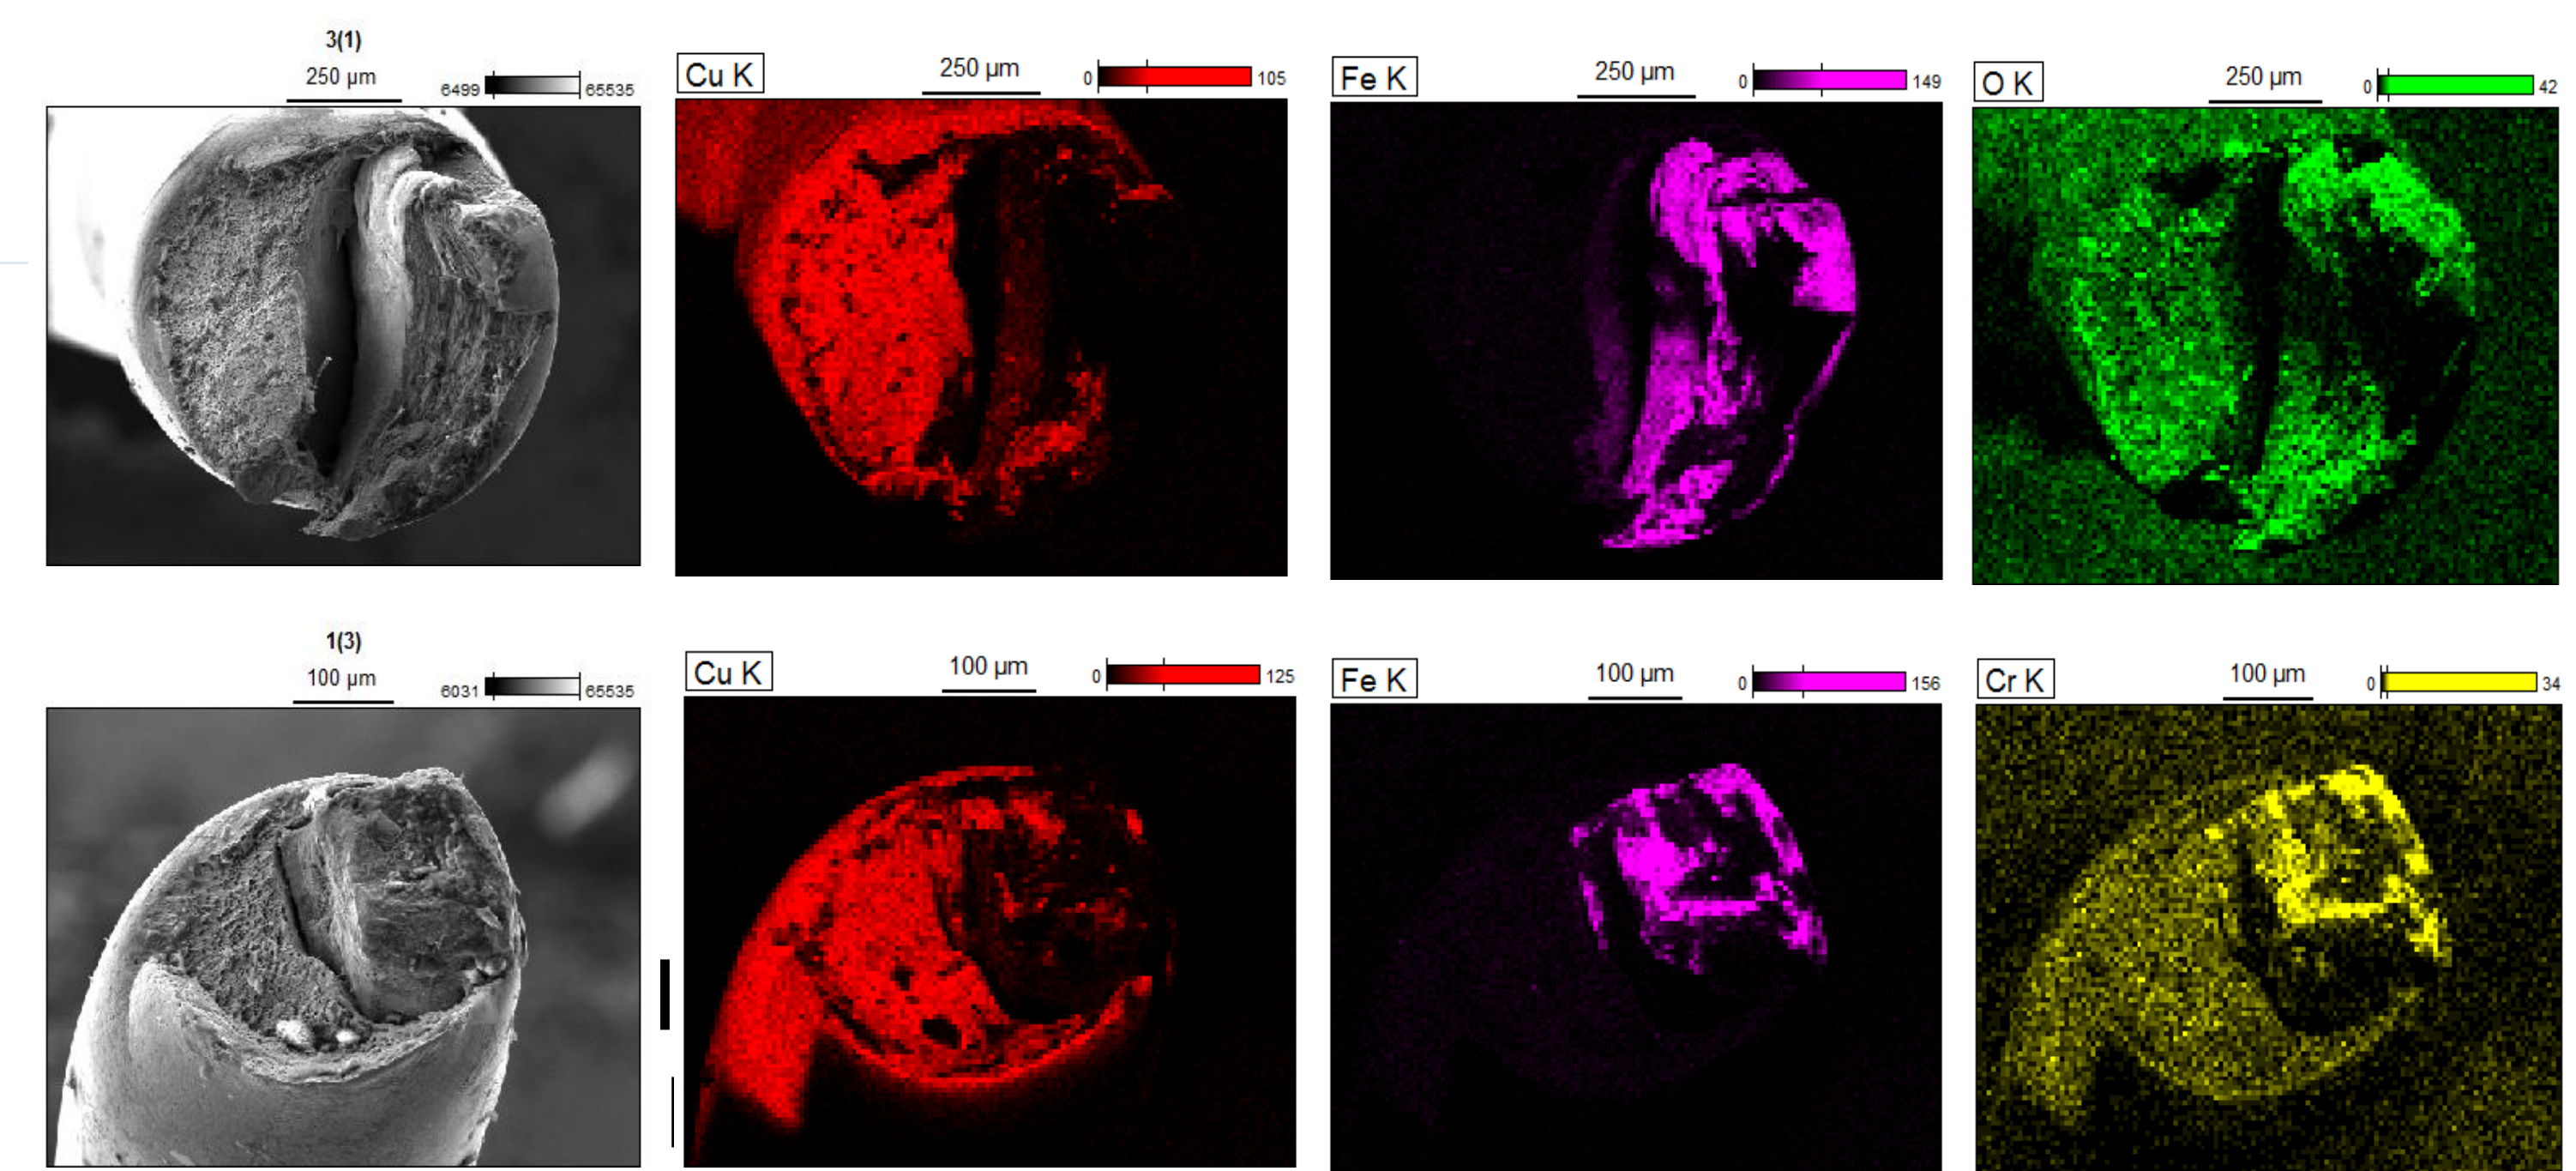
Fig.2. SEM image of Cu-ETP wires fracture and EBSD analysis, mag. x 500

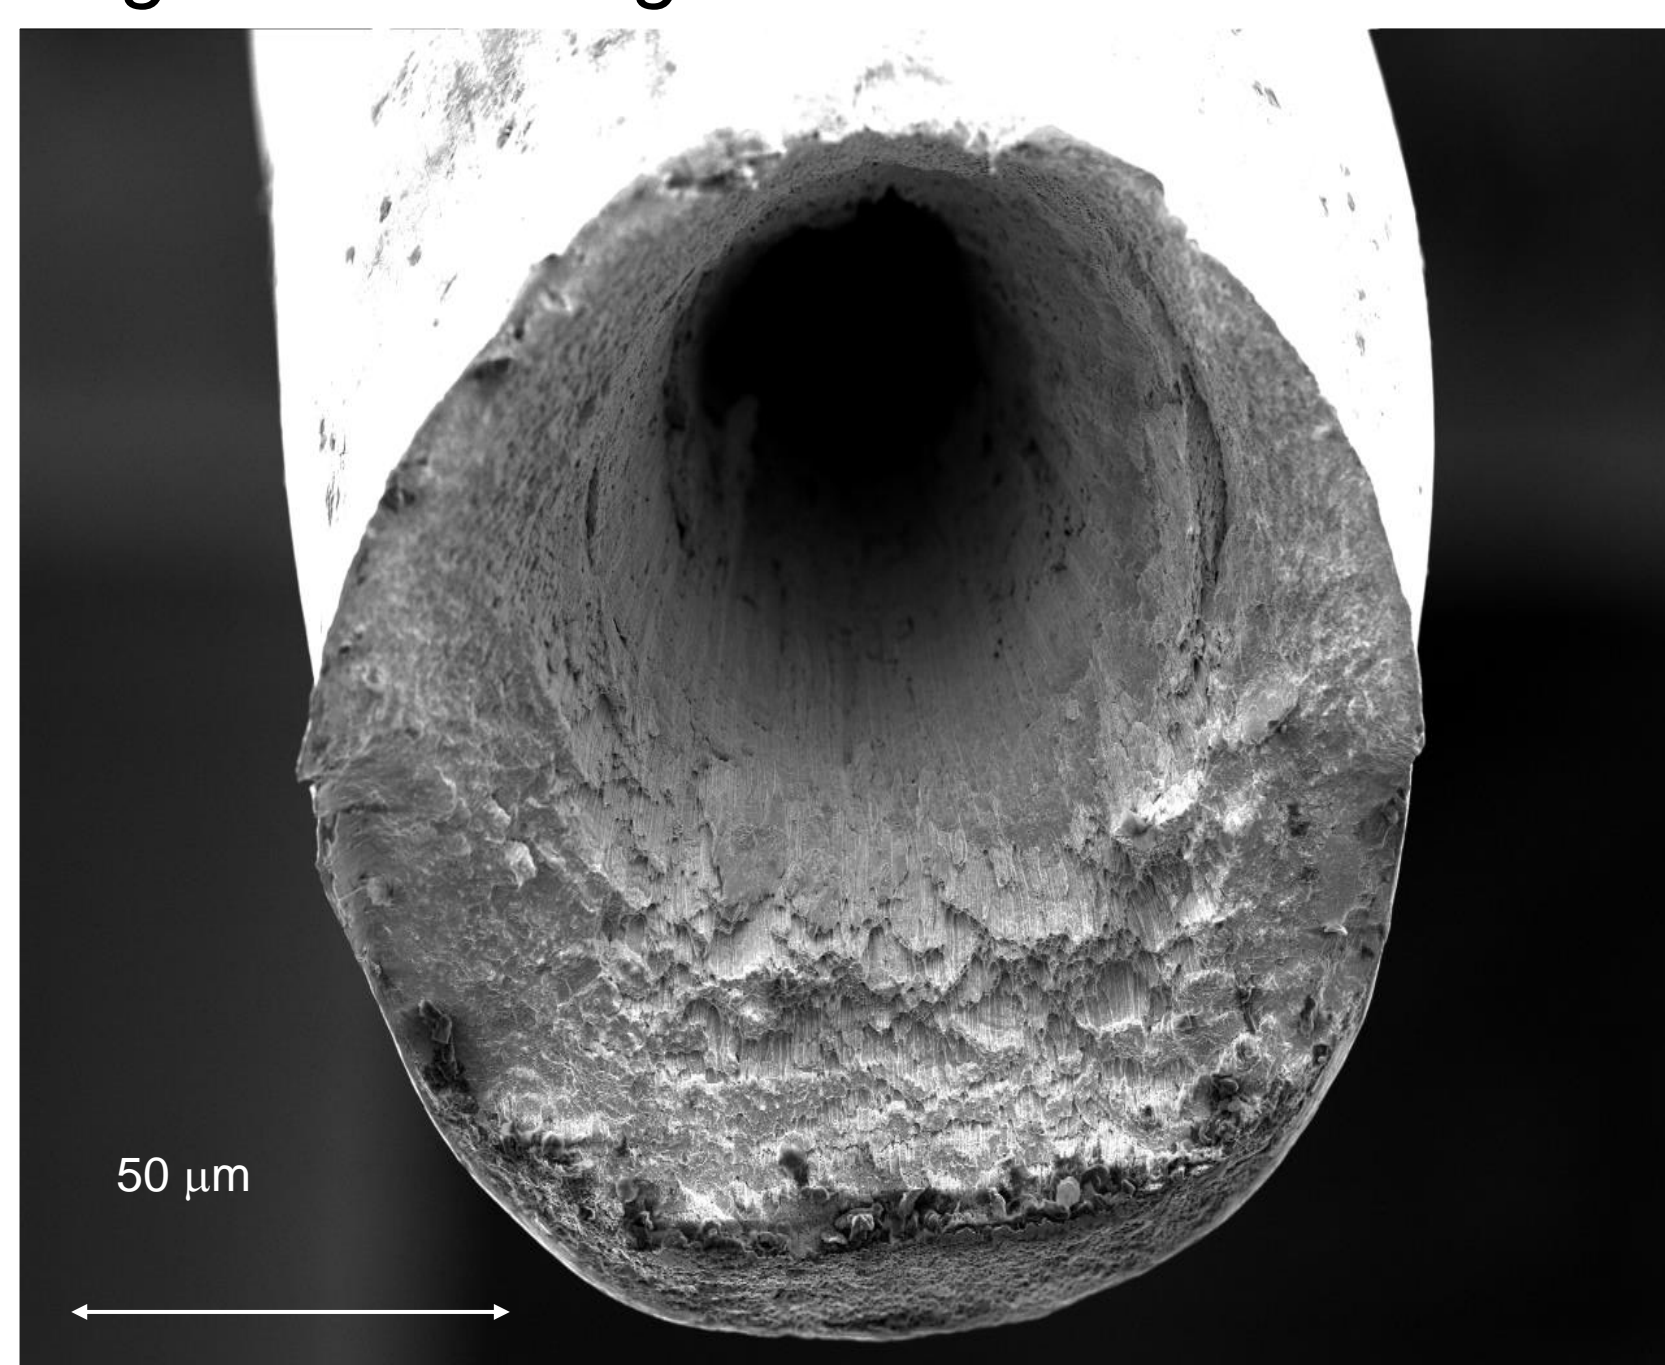
Fig.2. SEM images of Cu wires fracture, mag. x 50 (inclusions and hollows)

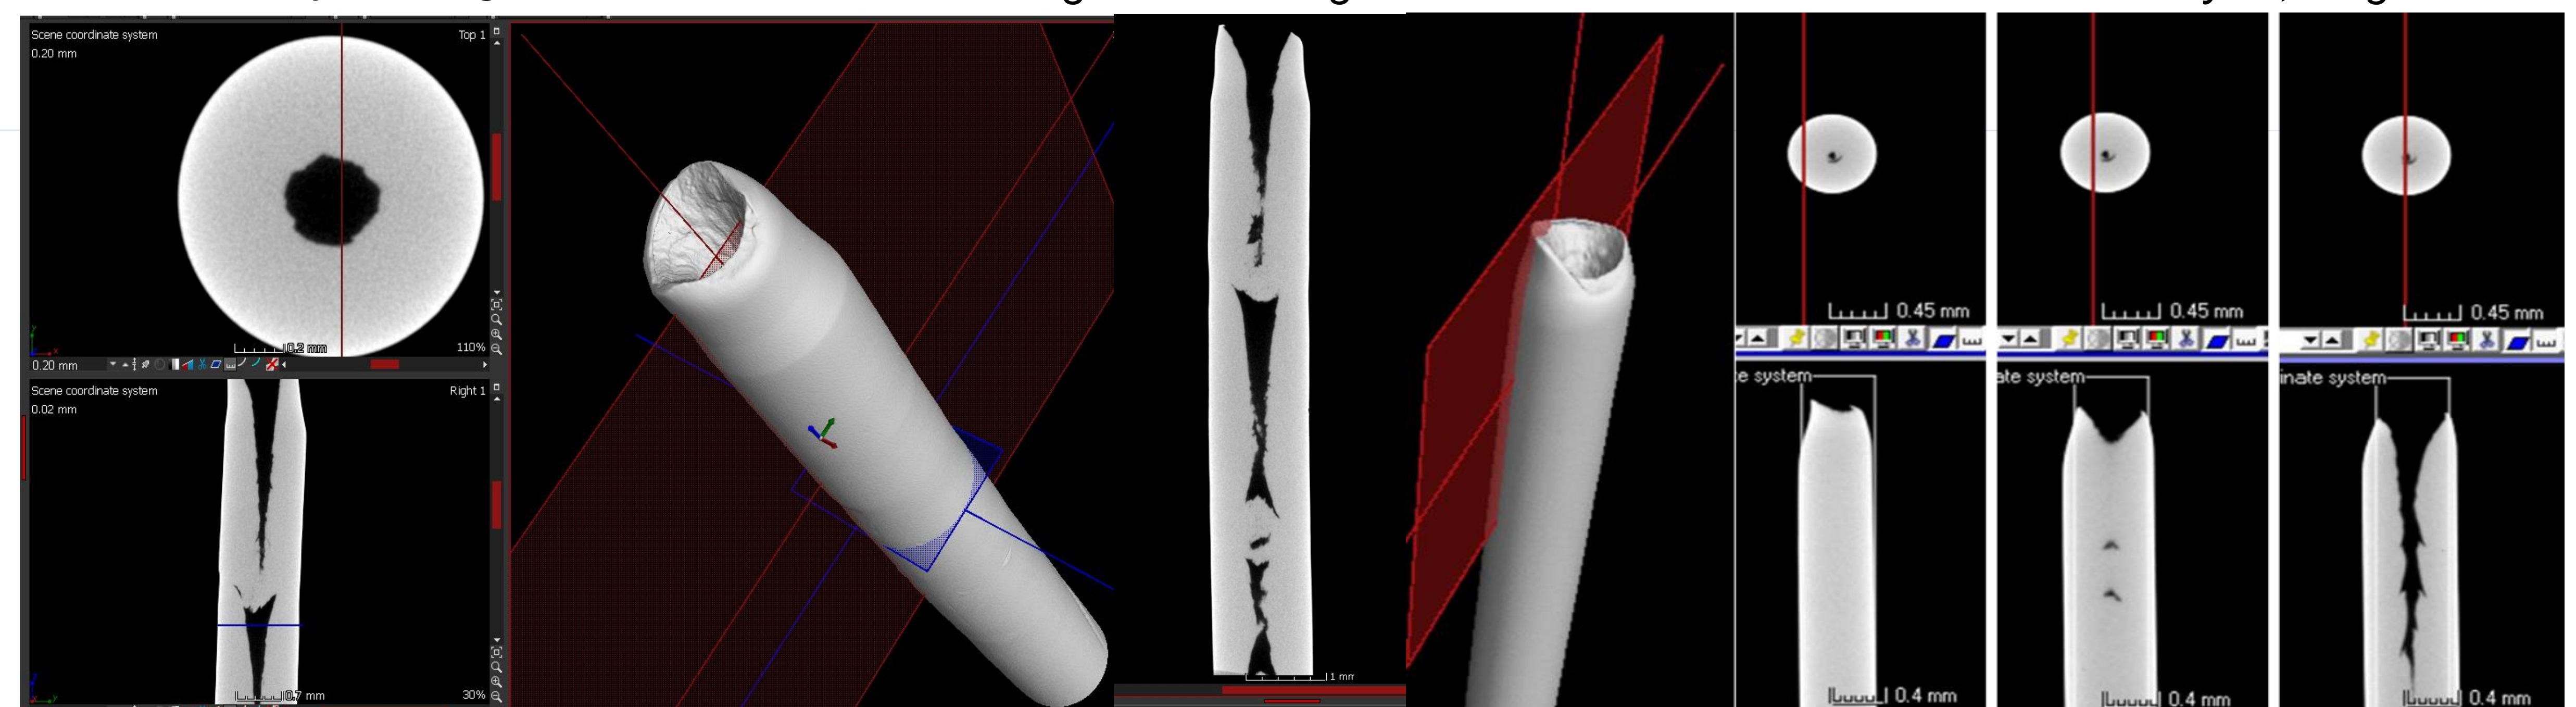
Fig.5. 3D computer tomography images of copper wires breakages (types: holloes)
