Strut through the heart: acute pericarditis and hemopericardium from an embolized IVC filter strut

Ellen Liu, MD, Laurie Bossory Goike, MD, Obiora Egbuche, MD, MPH, Alexander Meyer, MD, Asvin Ganapathi, MD

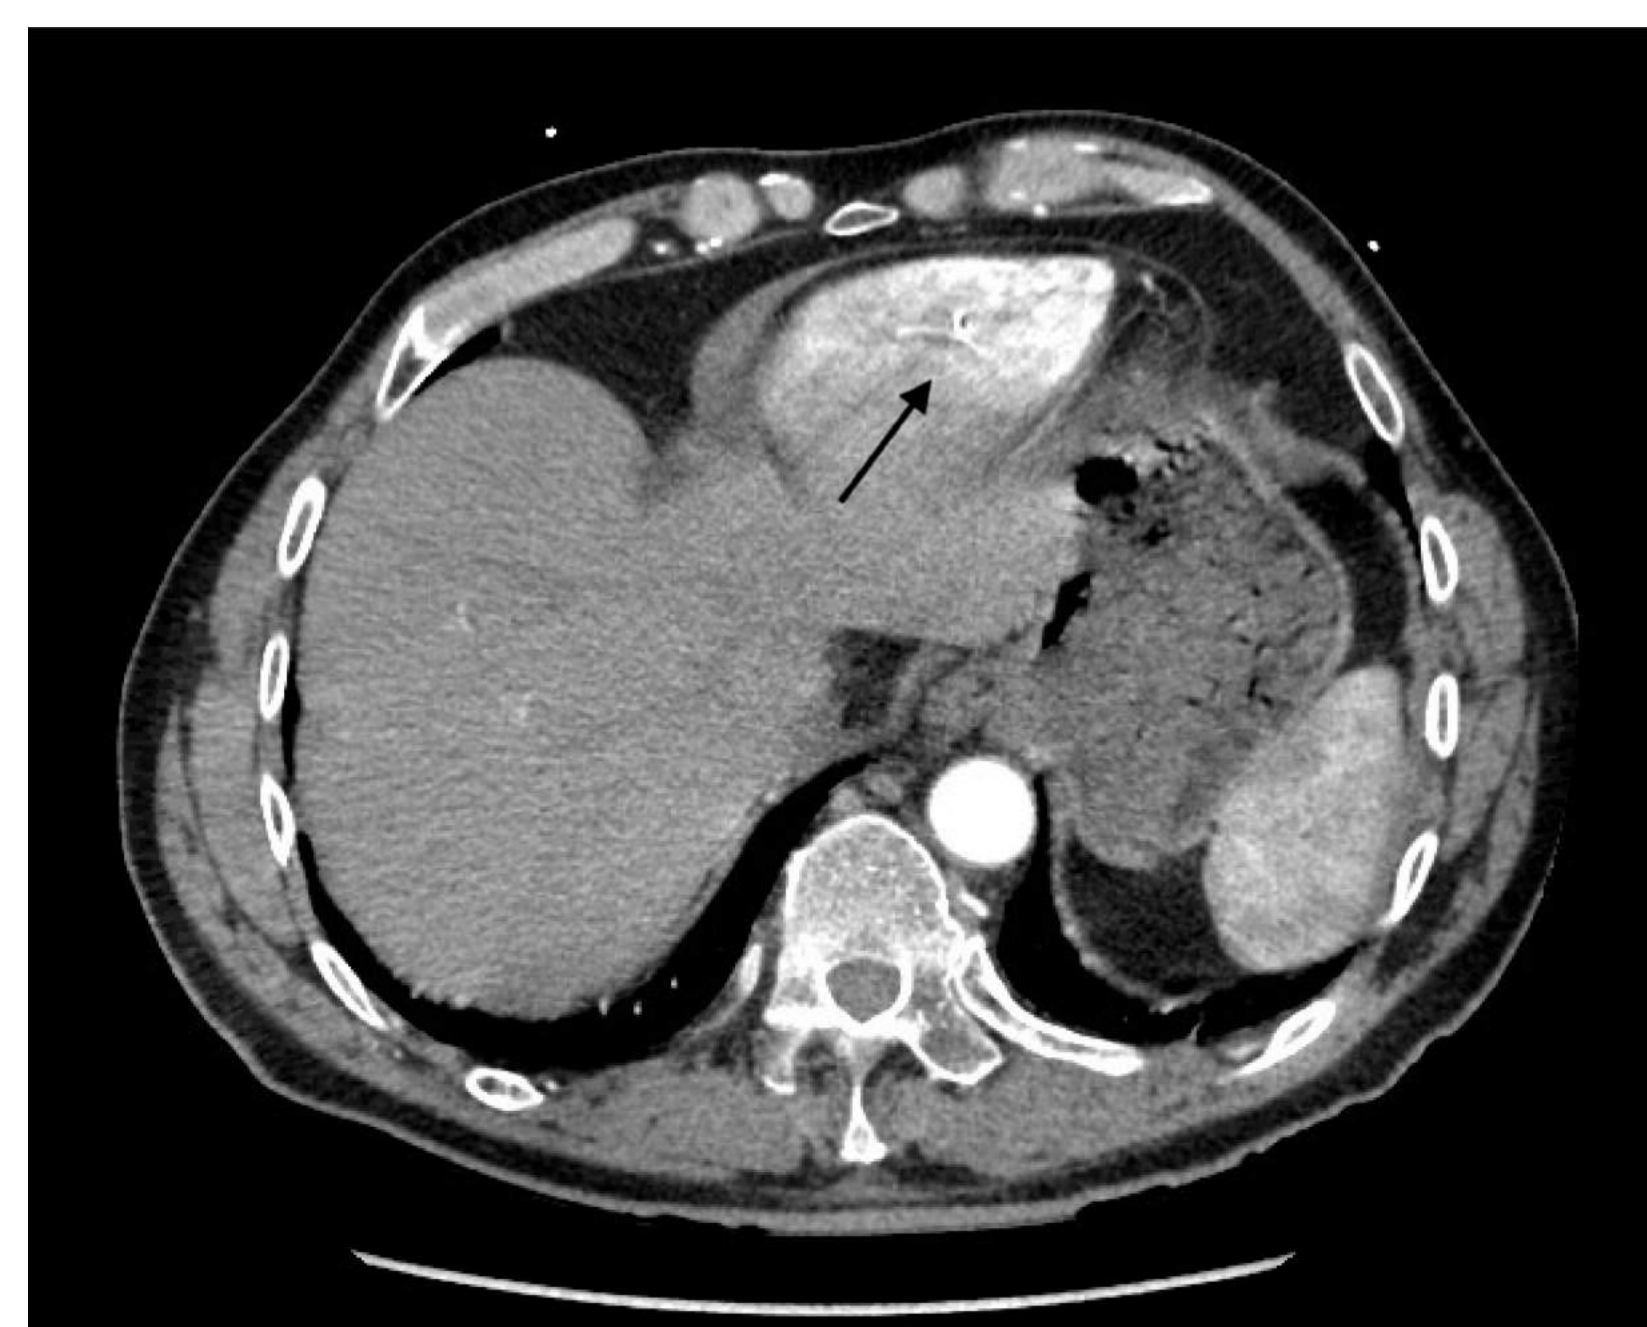
Figure 1: CT angiogram of the chest showing a density (arrow) within the right ventricle

- 71 year old male with a history of Factor V Leiden mutation, deep vein thrombosis on Warfarin status post IVC filter placement presented to his local emergency department due to ongoing chest pain.
- HS-troponin was 1036.2 pg/mL which downtrended. INR was 2.2. Initial electrocardiogram (ECG) revealed sinus bradycardia without any ST segment changes.
- Computed tomography (CT) angiography of the chest was negative for acute pulmonary embolism. A linear density was noted in the right ventricle (Figure 1).

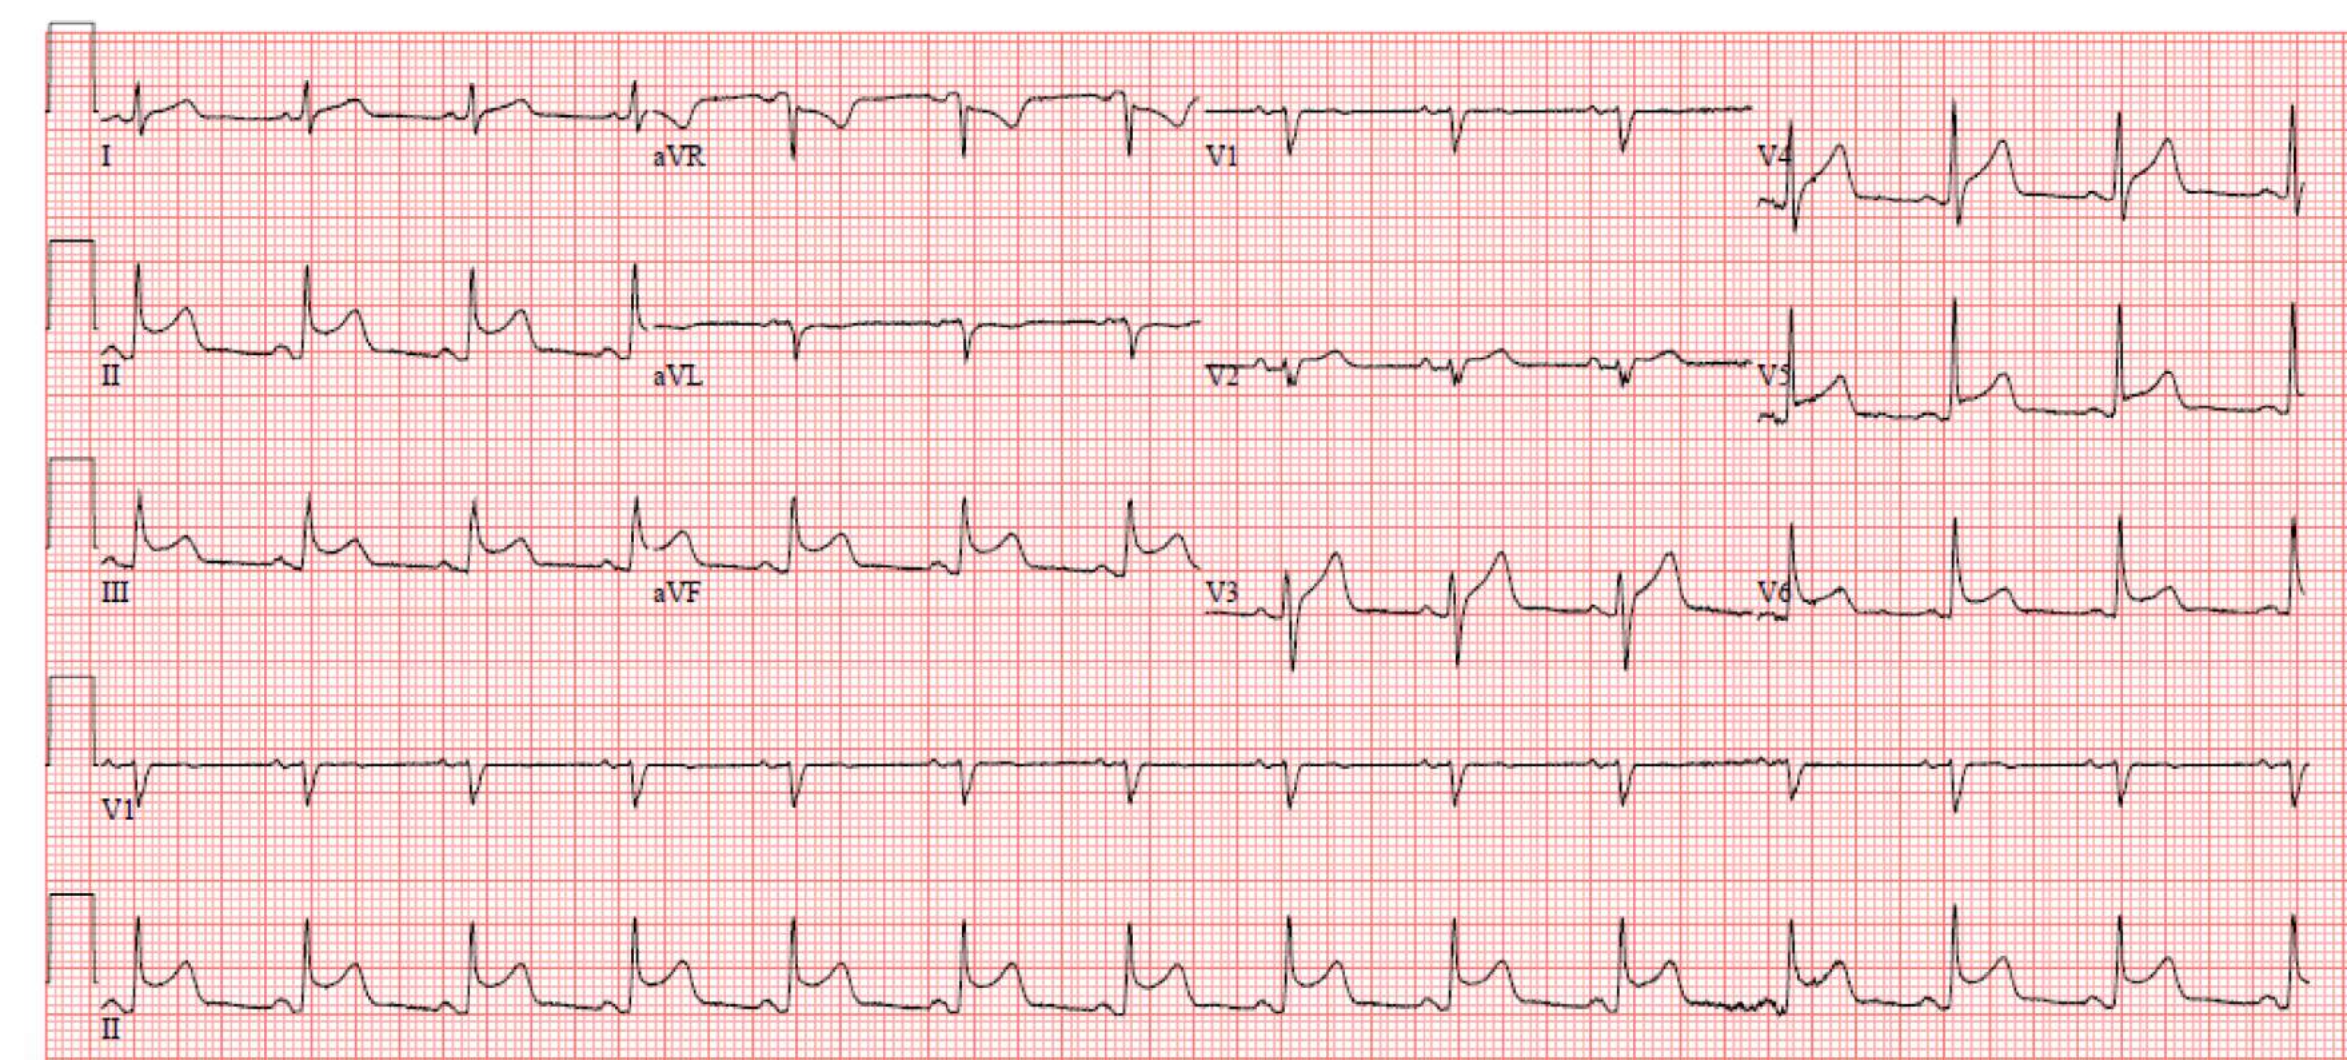
Figure 2: Electrocardiogram on admission showing diffuse ST segment elevation

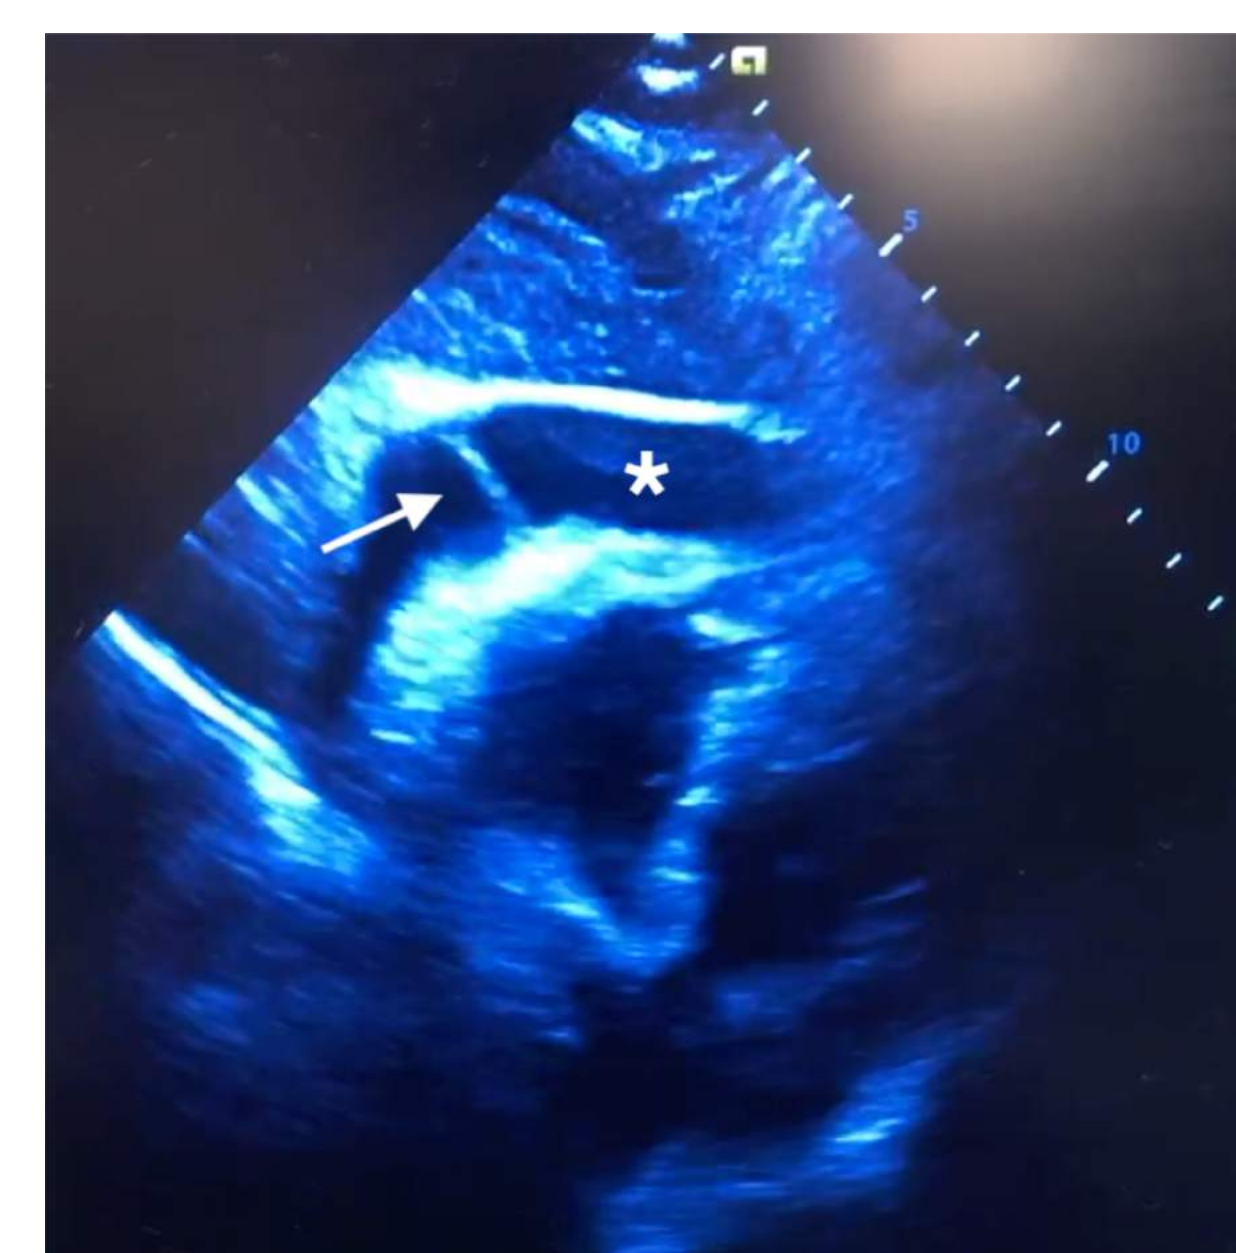
Figure 3: Subcostal view on bedside echocardiogram showing a linear density (arrow) adjacent to the right atrium and ventricle with a moderate to large pericardial effusion (asterisk)

- Transthoracic echocardiogram revealed a normal ejection fraction and trivial pericardial effusion.
- Coronary angiography revealed normal coronary arteries.
- Fluoroscopic images demonstrated a linear density associated with the right ventricle and the presence of an IVC filter with 11 struts.
- On arrival to the Ohio State University Wexner Medical Center, a repeat ECG (Figure 2) revealed diffuse ST elevation consistent with pericarditis. HS-troponin remained stable at 772 pg/mL.
- Repeat echocardiogram (Figure 3) showed an enlarging pericardial effusion with a linear echo density within the pericardial space adjacent to the right atrium and ventricle, concerning for strut migration from within the ventricle into the pericardial space.

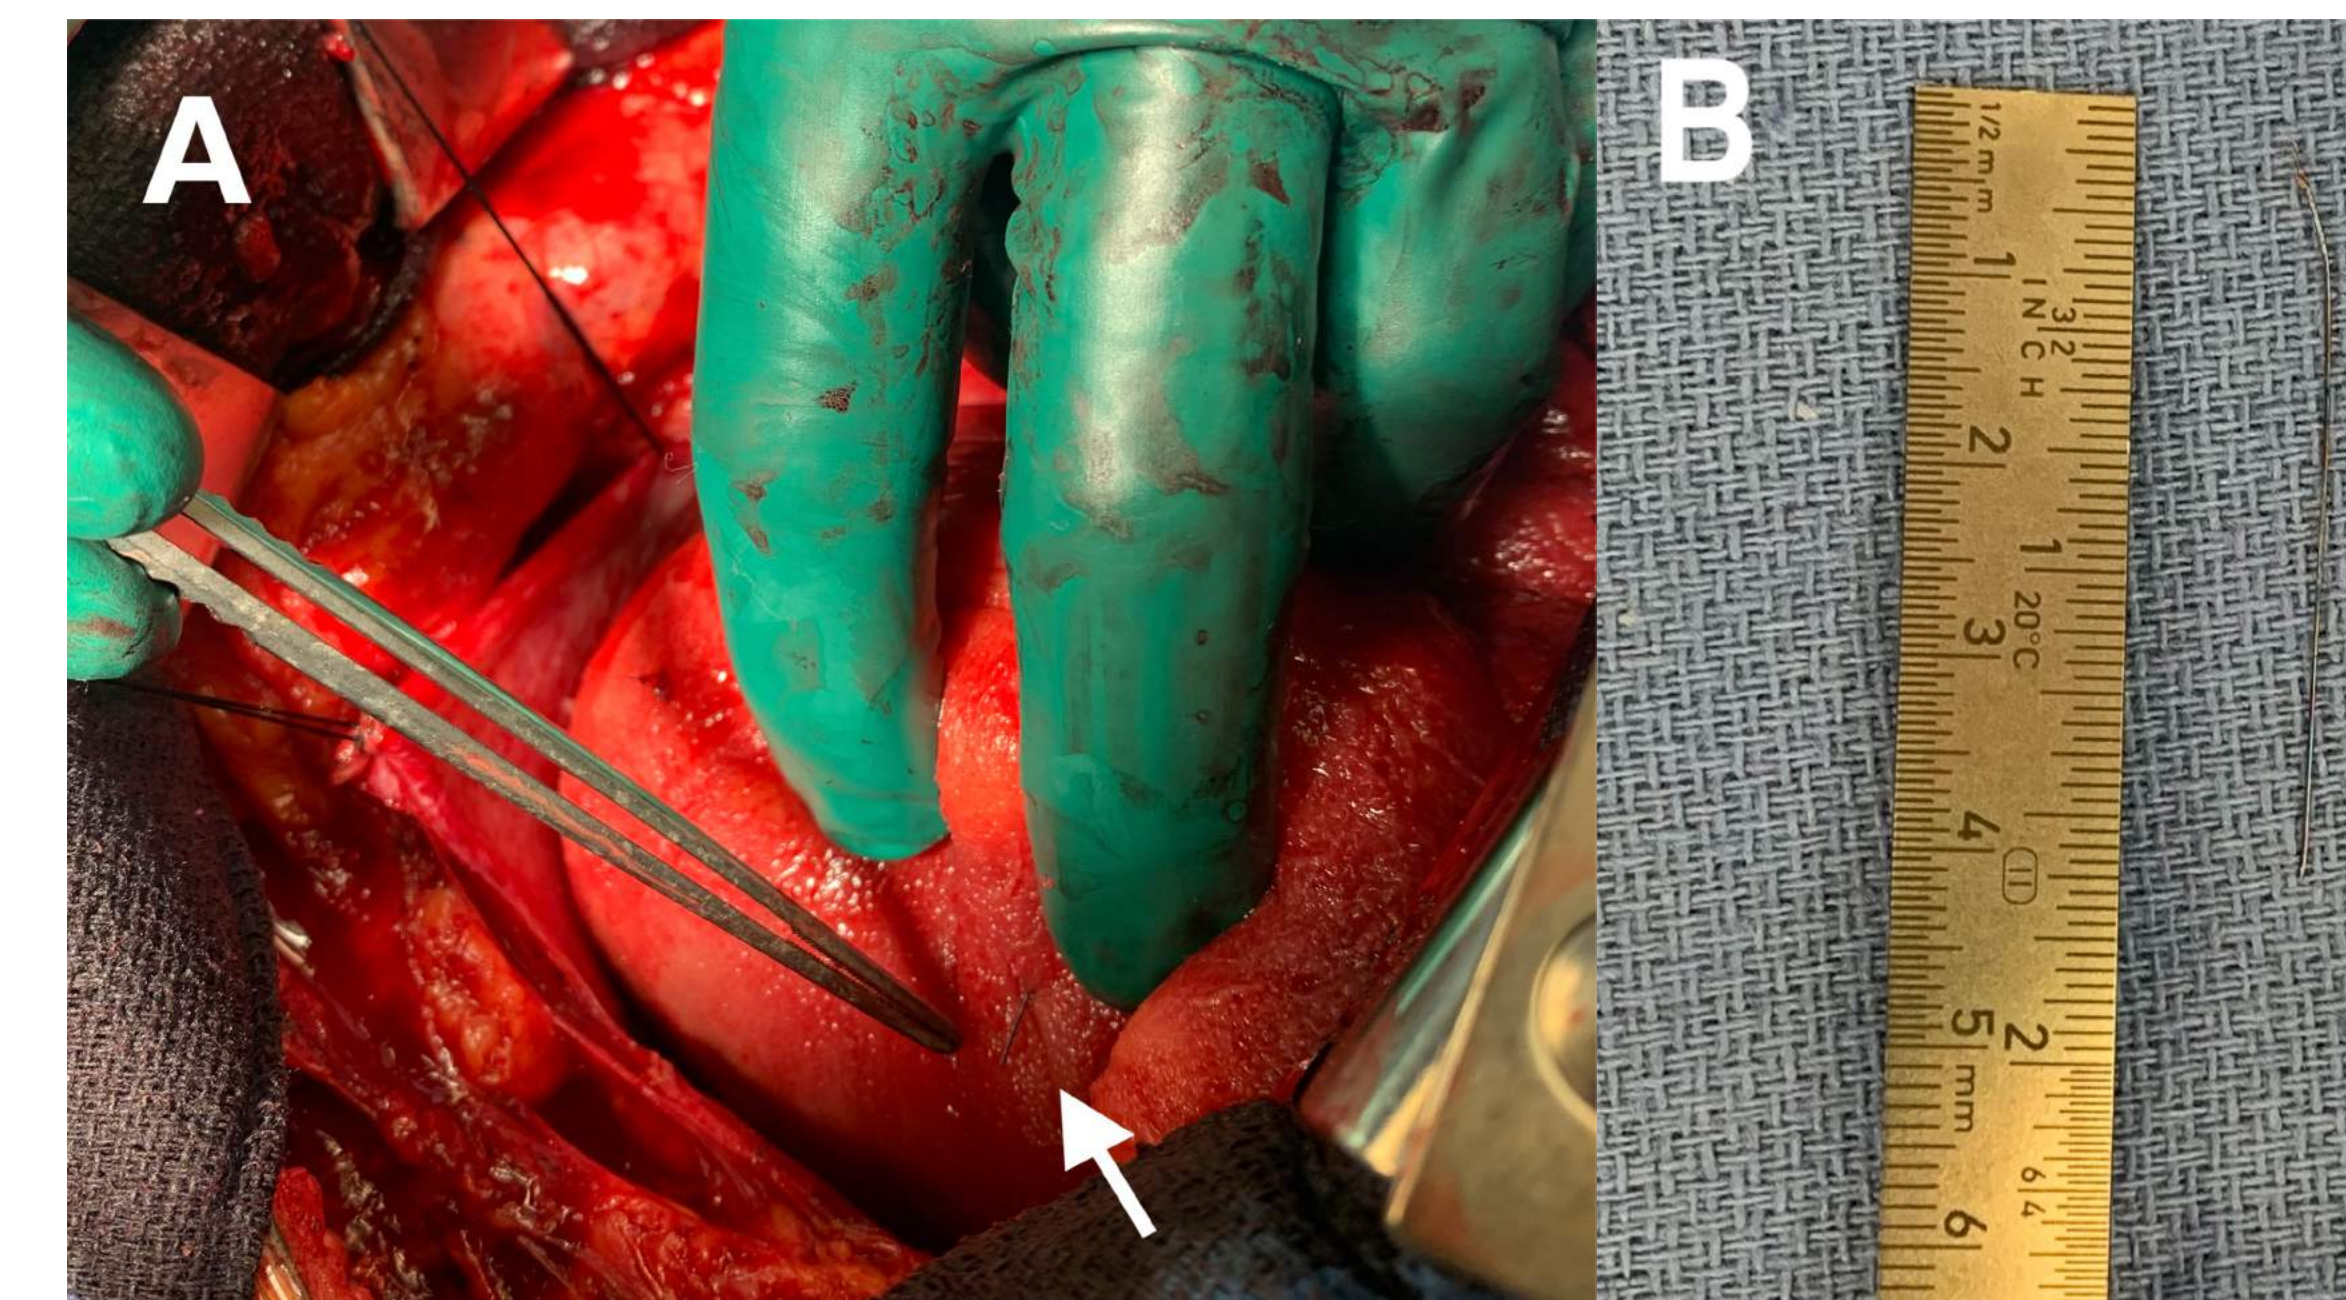
Figure 4: Intra-operative view of the IVC filter strut within the myocardium (A, white arrow) and following retrieval (B)

- The patient was brought urgently to the operating room where bloody pericardial fluid was evacuated and an IVC filter strut was removed from the inferior wall of the right ventricle (Figure 4).
- A subsequent CT of the abdomen revealed an infrarenal IVC filter with eleven legs, multiple extending outside the IVC lumen. Decision was made to forego retrieval due to the high risk nature of the procedure.
